LiPo deterioration

By Bob Smith

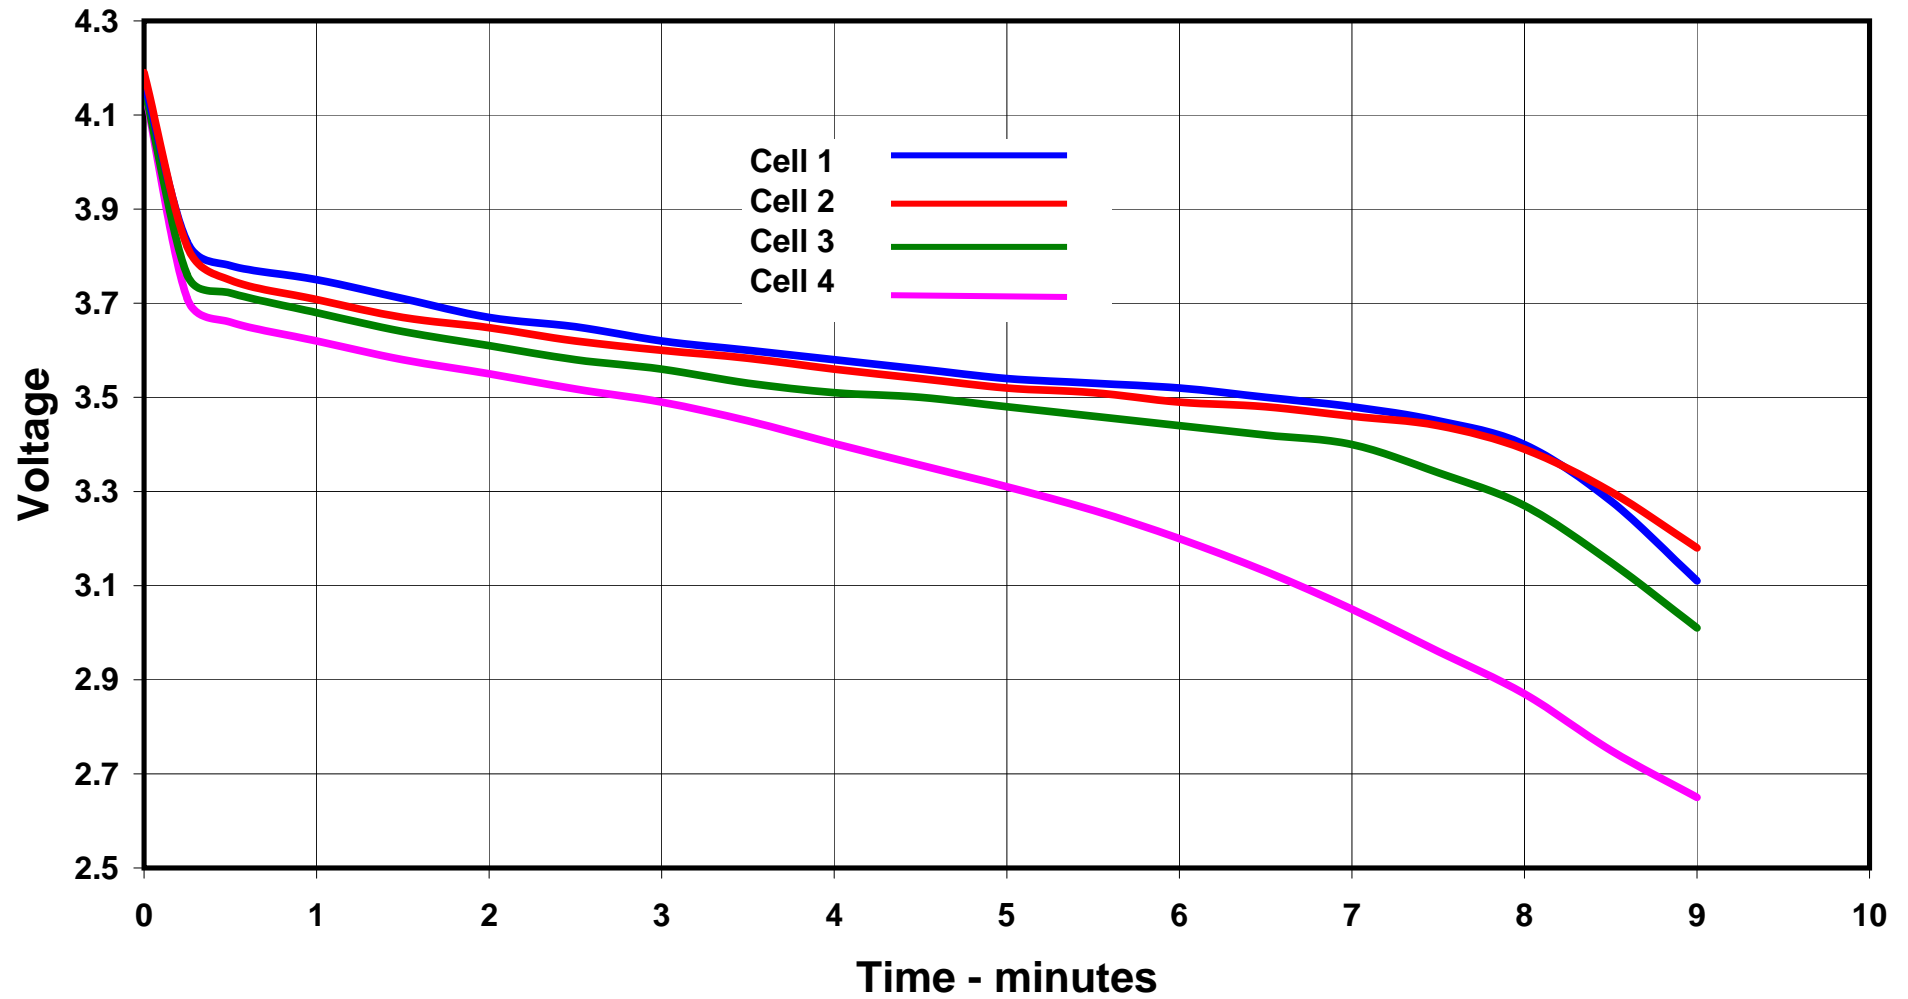
It is now easy to see why the first pack was producing reduced capacity. Of the 4 cells, cells 1 and 2 were OK, but 3 was well down and 4 was critically low. Even though the cells were balanced during charging, this procedure was not able to correct the problem with cells 3 and 4, and the discharge cut-off was exacerbating the situation. In this test, I used a manual cut-off when cell 4 became critical and the total voltage at this point was 12.0. If an auto cut-off had been used set at 2.9 volts per cell (11.6 v total), the readings at the end of discharge would have been lower still with cell 4 being subjected to even further damage by each cycle. The point about recovery masking the extent of the imbalance is given by the cell voltages at the start of the charge, which were 3.62, 3.62, 3.55, and 3.48 volts. These give a clue that there may

be a problem but do not indicate its magnitude, especially when the balanced charge brings all the cells back to 4.2 volts.

Graph 1 - Individual cell voltage at 20 amp Discharge - problem 4s pack.

My conclusions from this brief investigation are that we need to check the balance of our series LiPo packs in terms of discharge as well as charge. It would be nice if we could apply the same active logic that we use in charging to the pack whenever it is discharging but that may not be feasible in the model during flight. What may well be helpful is an occasional bench discharge using a system which displays the traces of individual cell voltages throughout discharge but again I do not know of such a system at the moment. I imagine that the hardware/software used for the balanced charger could be adapted to this task, i.e. a balancing charger/discharger, but until such a unit is available I will use my set of DVMS to give me occasional checks.

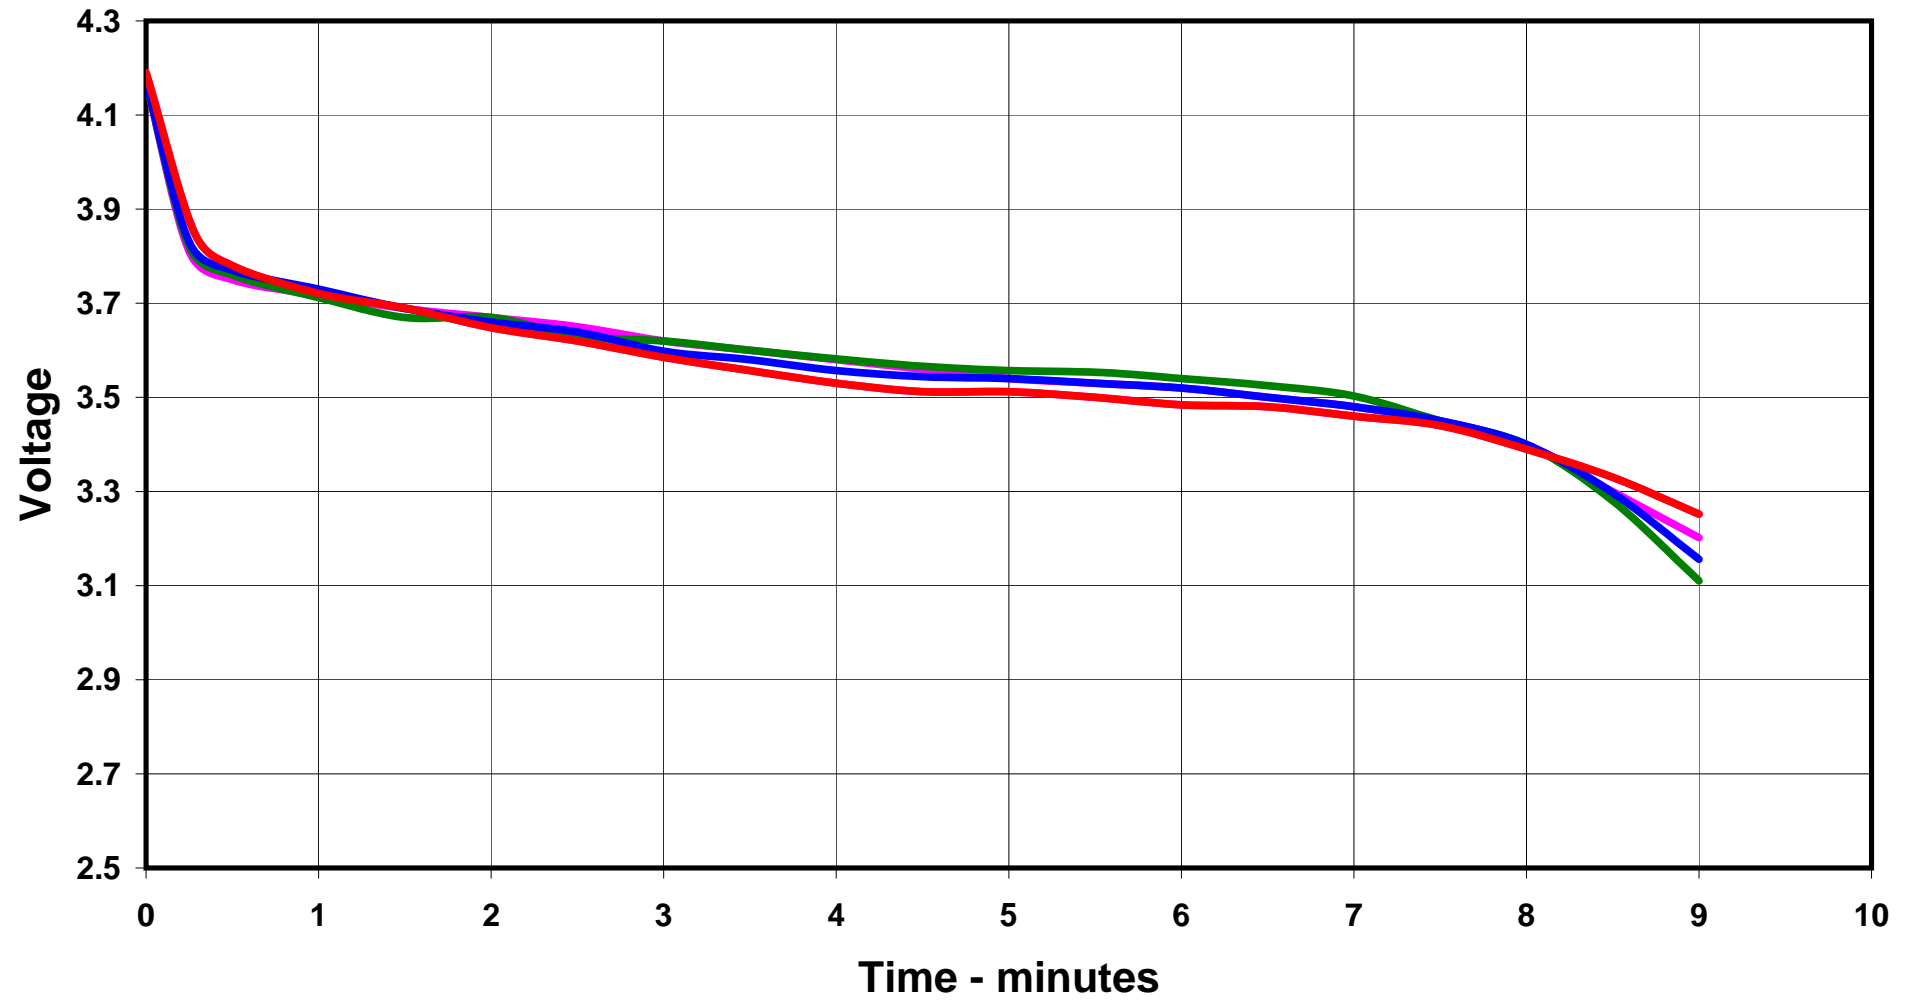
Graph 2 - Individual cell voltage at 20 amp Discharge - new 4s pack.
