## Thermographic Survey at

## Beer Breweries Ltd

**Report No. B1234**

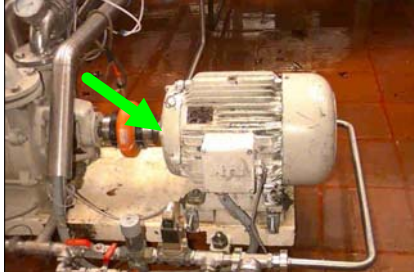
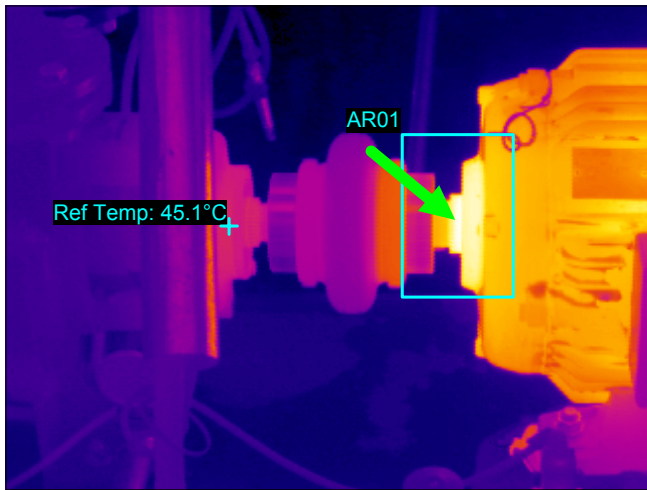
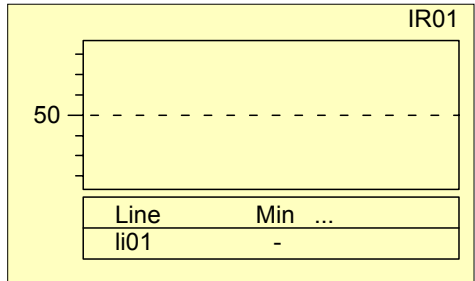
Location	Pump House
Equipment	Motor No. 5
Component	Bearing M/S
Date	10/12/1996
File Name	Trial1b.img

<i>Fault</i>	<i>Hot Bearing</i>
--------------	--------------------

Max Temp in Area	86.8°C
Ref Temp	45.1°C
Mean Temp. Rise	41.7°C

Inspect ASAP

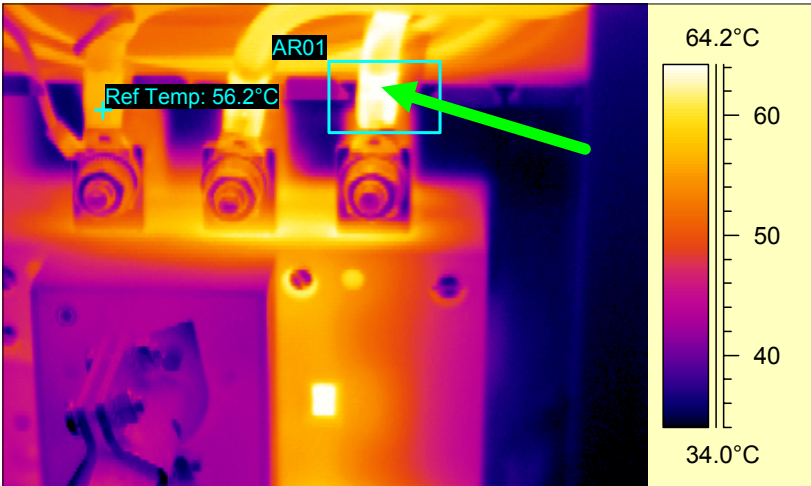
Location	Machine Shop
Equipment	No. 3 Panel
Component	Blue Phase
Date	20/01/1998
File Name	I0120-55.img

<i>Fault</i>	<i>Hot Termination</i>
--------------	------------------------

Max Temp in Area	65.5°C
Ref Temp	56.2°C
Mean Temp.Rise	9.4°C

**Change Next Shutdown**

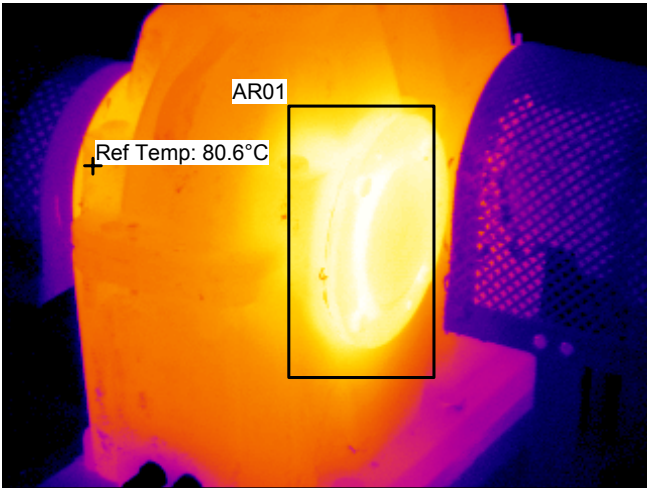
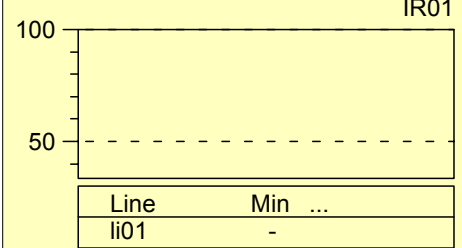
Location	Production
Equipment	Main Gearbox
Component	Bearing
Date	29/05/1998
File Name	I0529-28.img

<i>Fault</i>	<b>Very Hot</b>
--------------	-----------------

Max Temp in Area	101.2°C
Ref Temp	80.6°C
Mean Temp. Rise	20.6°C

**Inspect Urgently**

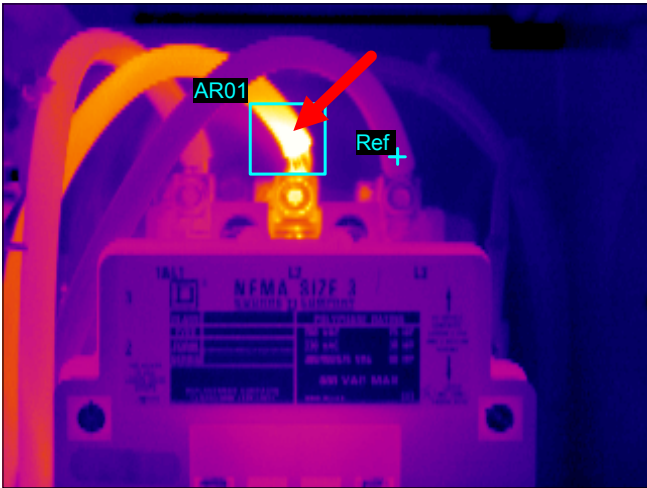
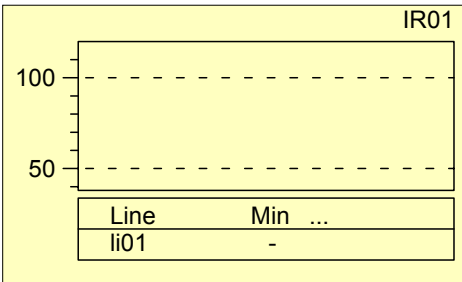
Location	Boiler House
Equipment	Main Panel
Component	Red Phase
Date	25/09/1997
File Name	H0924-27.img

<b>Fault</b>	<b>Very Hot Connection</b>
--------------	----------------------------

Max Temp in Area	127.5°C
Ref Temp	58.2°C
Mean Temp. Rise	69.2°C

**Change Urgently**
