# Fairview Allotments Association

Site Risk Assessment 7 Jan 2008

A site risk assessment has been carried out using guidelines contained in the document pack "Health and safety on allotments: A management guide" provided by The Allotments Regeneration Initiative ([ari@farmgarden.org.uk](mailto:ari@farmgarden.org.uk)).

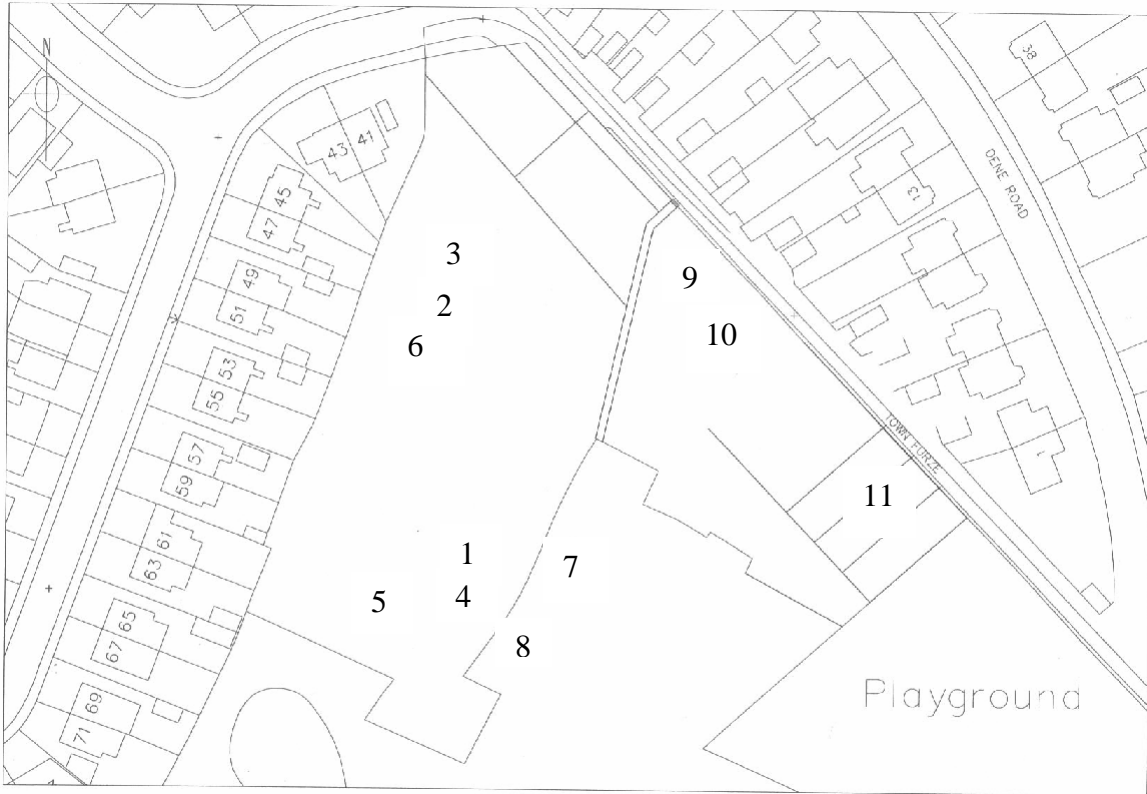
Site map. Hazard locations are approximate only.

4.	Communal paths/roadways	<p>Mostly flat but some pathways broken down (see map locations 7, 8), presenting slip hazards. <b>ACTION:</b> Adjacent ploholders to improve.</p>

Hazard (location)	Degree of risk	Action needed	Date for completion or review	
Asbestos (1)	$(4+8) \times 4 = 48$	Substantial risk. <b>Action required:</b> Contact OCC for disposal advice and remove from site	1 April 2008	
Broken glass (2) – was part of cold frame	$(2+8) \times 3 = 30$	Possible risk. <b>Action recommended:</b> Remove from site	1 April 2008	
Large glass panels, some broken (3)	$(2+8) \times 3 = 30$	Possible risk. <b>Action recommended:</b> Remove from site	1 April 2008	
Iron sheets – rusty with sharp edges (4)	$(2+8) \times 3 = 30$	Possible risk. <b>Action recommended:</b> Remove from site	1 April 2008	
Overgrown wire fencing approx 40cm high (5)- trip hazard	$(2+5) \times 4 = 28$	Possible risk. <b>Action recommended:</b> Move and store safely	1 April 2008	
Plastic and wooden debris (with protruding nails) (6)	$(2+8) \times 3 = 30$	Possible risk. <b>Action recommended:</b> Remove from site	1 April 2008

Glass bottles (9)	$(2+7) \times 2 = 18$	Remove from site as part of general rubbish clearance.	1 April 2008	
Short ditch with debris at bottom – depth 50cm x length 2m) (10 and 11)	$(2 \times 2) \times 4 = 16$	Fill ditch using material from bank behind. Remove debris from ditch as part of general rubbish removal.	1 April 2008
