**RE: STOCKTON HEATH PRIMARY SCHOOL - FEASIBILITY STUDY
NORTH BOUNDARY WALL TO PLAYGROUND**

STOCKTON HEATH PRIMARY SCHOOL

Rear Boundary Wall

2839

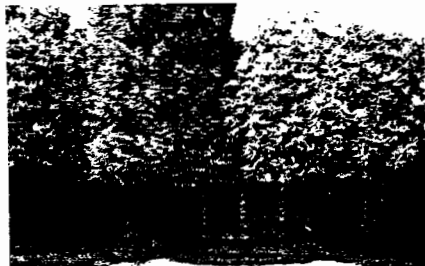
Wall H

H. Length of General Boundary Wall 225mm thick approximately overall with a terracotta coping, and in the order of 1800mm high from playground level.

Apparently unbuttressed. The wall is of early construction, probably constructed at the same time as the Primary School. For its height, the wall is slightly higher than that which could be justified to current Codes of Design, but appears generally to be performing satisfactorily. Mature trees/bushes growing adjacent have had no obvious detrimental effect.

Recommendation: No work is presently recommended.

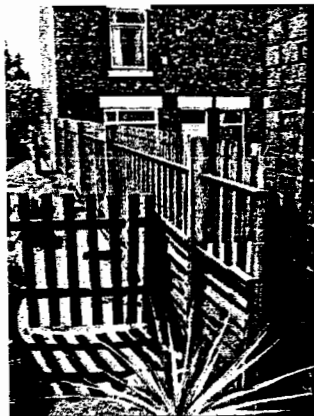
Wall F

F. Original Retaining Wall at the End of the Roman Road.

Retaining wall performing satisfactorily with no evidence of significant distress. Substantial steel palisade fence protects school side. Local distress where old railing bases beginning to corrode, where built-in.

Recommendation: No work presently recommended.

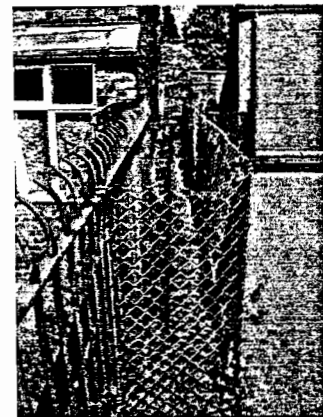
Wall E

E. Low Level Boundary Retaining Wall.

Height of playground retained approximately 950mm. Header copings at approximately playground level. Although aged, the wall appears to be performing reasonably satisfactorily. 'Protected' on playground side by chain link fencing.

Recommendation: No work presently recommended.

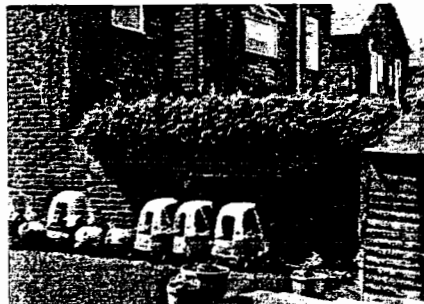
Wall G

G. The 'School' Wall lining through with that extending towards the Right Hand Pavilion, steps where abutting a 'garden' wall of one of the adjoining properties.

The garden wall has been rebuilt in part at high level with a new coping. It is bonded to the house wall. Height to top of wall from playground level 1750mm. Part ivy covered, some weathering of pointing and slight evidence of possible settlement. For its height, the wall is slightly higher than that which could be justified to current Codes of Design, but appears generally to be performing satisfactorily.

Recommendation: No work presently recommended.

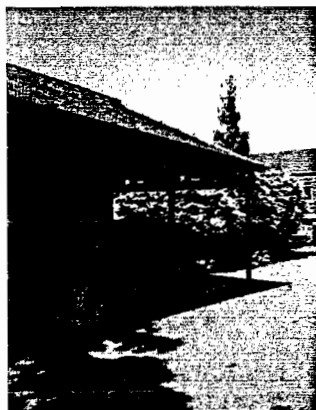
Pavilion Wall B

B. Left Hand Pavilion.

The construction mirrors that of the Right Hand Pavilion on which a short report was prepared in August 2004. The present condition of the pavilion and rear wall to same is not of concern. Comments regarding removal of the pavilion as indicated in the August 2004 report apply.

Recommendation: No work presently recommended.

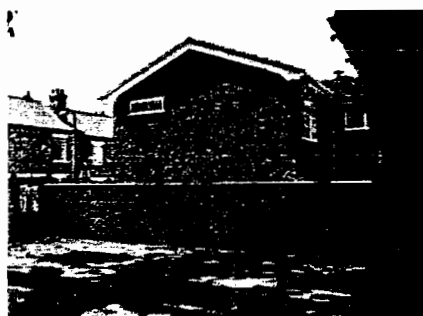
Wall A

A. Half Brick Wall with Buttrressing Piers 300 long x 100mm projection at 1600mm centres.

Height of wall 1500mm on playground side. Wall thickens out below playground level to retain approximately 1metre of ground down from playground level, to path to adjoining property. Our inspection noted some missing mortar coping, but no other evidence of obvious distress.

Assessment: This wall could not, in our opinion, be justified to current Codes of Design. Whilst exhibiting no significant distress, it would be prone to collapse should it be subject to acts of vandalism.

Boundary Wall Length A, (Half Brick with Piers) is considered at risk should it be subject to acts of vandalism. We therefore recommend additional buttressing, rebuilding or strengthening.

Recommendation: Additional buttrressing or strengthening recommended.

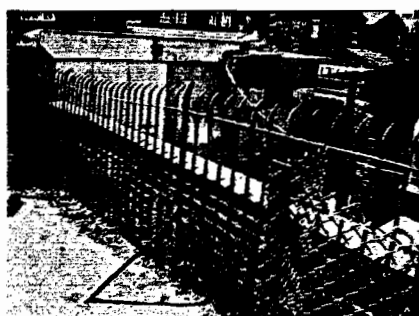
Wall D

D. Low Level Retaining Wall to garden to adjacent property.

The 225mm thick wall extends 900mm above playground level, and retains approximately 700mm of ground (garden level lower). The wall bows slightly in its length, and is significantly out-of-plumb for approximately 4metres. It is possible that at some time the wall has been subject to impact damage. Railings 'protect' the wall from the playground side. The degree of displacement is not of immediate concern. No evidence of active movement or recent distress.

Recommendation: Monitor.

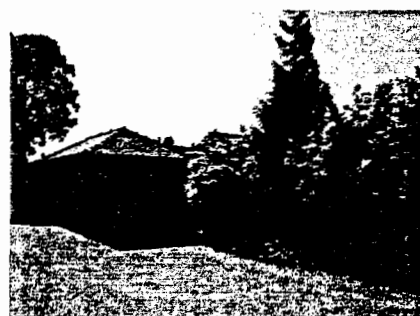
Wall C

C. Length of General Boundary Wall, 225mm thick approximately overall, with a terracotta coping, and in the order of 1800mm high from playground level.

Apparently unbuttressed. The wall is of early construction, probably constructed at the same time as the Primary School. For its height, the wall is slightly higher than that which could be justified to current Codes of Design, but appears generally to be performing satisfactorily. Mature trees/bushes growing adjacent have had no obvious detrimental effect.

Recommendation: No work is presently recommended.
