Asbestos Survey Report

Property: STOCKTON HEATH CP
SCHOOL
EDGERTON STREET
STOCKTON HEATH
WARRINGTON
CHESHIRE
WA4 6DT

Property Ref: WN2112

Task No.: 115977

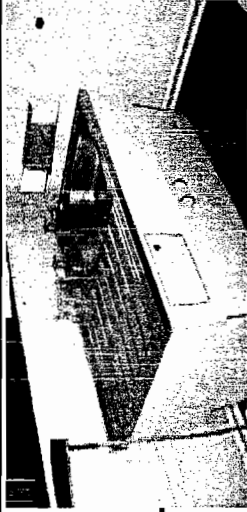
Record ID: 1447812
MDHS 100 Survey Type: Type 2
Task No: 115977

Floor Level and room ID	Room Description	Material Description	Approx Amount	Sample Comments
47	47 T A41 P25	Sink Pads Bituminous Product	2	062/408 2 no. bituminous pads to underside of sink unit. Roof void not accessed.

4

Bituminous Product	1
Good Condition-no visible damage	0
Composite materials reinforced plastic, resins etc	0
Chrysotile	1
Analysis: Chrysotile Trace

MDHS 100 Risk Score (out of 12): 2 + Dutyholder's Risk Score (out of 12, as per HSE guidance): 6 = Total Risk Score TRS (out of 24): 8
